Hydrodemolition - Case Study

Road Overbridge – Kaikoura Coast

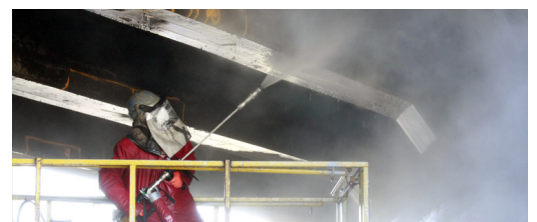
High pressure wash down

Aquamax got involved and was able to deliver a high quality result. A team was put together from Auckland and Christchurch with the right expertise to complete the job efficiently. We provided a high-pressure wash down and followed this with careful hydrodemolition to a depth of up to 100 mm to remove concrete cover exposing rebar.

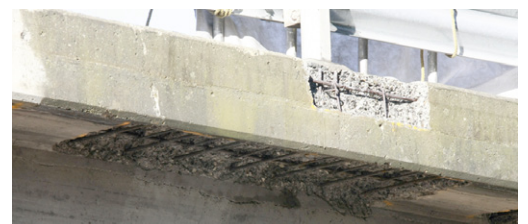
Prepared repair sites

- ▼ All loose concrete and rust scale removed
- ▼ No damage to steel
- ▼ Highly controlled process
- ▼ Clean and stable substrate ready for re-instatement of concrete
- ▼ Reliable, professional and safety conscious team
