Surface Preparation - Case Study

Port of Napier Tug

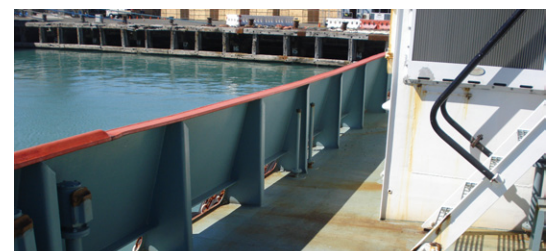
Deck areas before hydroblasting

Aquamax got involved and put together a project methodology to enable a comprehensive strip of the deck and pilot house to a SA 2.0 (medium) standard without use of garnet. The wet process assisted the containment of dust and blasting debris and the project was completed on the water, in line the client's environmental requirements.

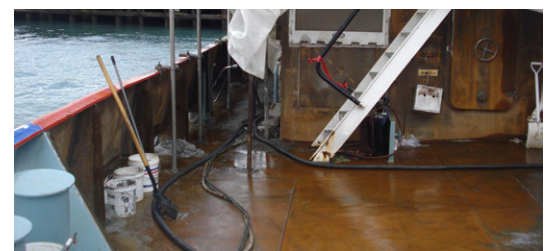
Deck areas after hydroblasting
